Conserving the “White Heron”

In 2009, a five-year project was launched to carry out repairs to the main keep of Himeji Castle in Himeji, Hyogo Prefecture. Toshio Matsubara went to see the castle in its full glory, now more visible than ever while repairs are ongoing.

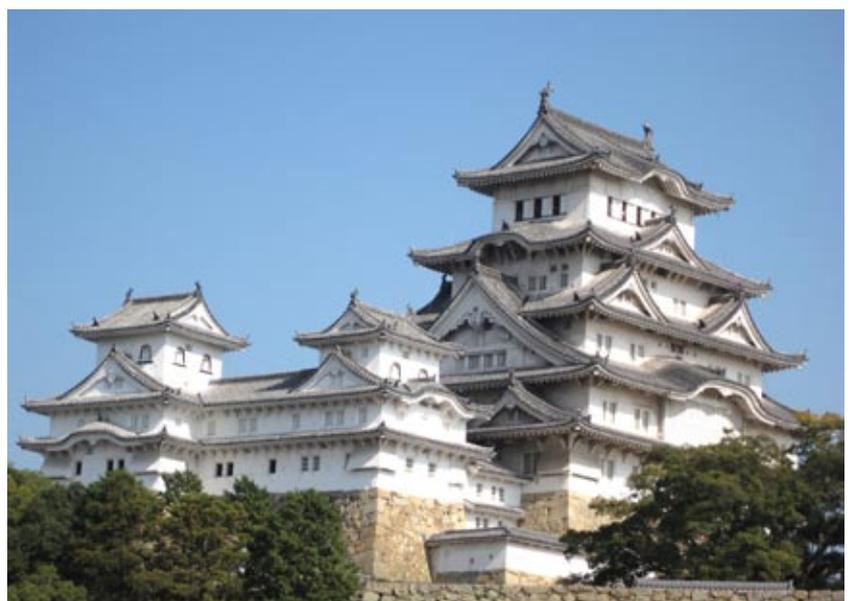
Himeji Castle prior to the start of restoration work, April 2010. The main keep of the castle has five levels with white plaster walls. The castle was listed as a World Heritage Site in 1993.

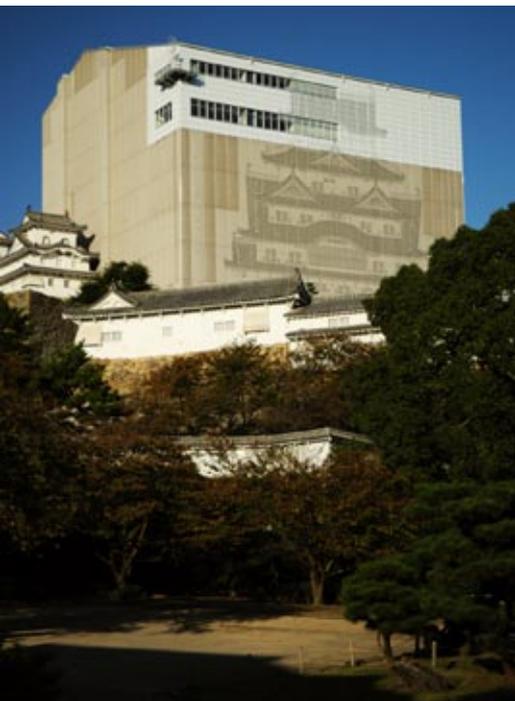
Himeji Castle covered by roofed scaffolding. The visitor facilities in the scaffolding are open from 9:15 to 16:30 (Sept. 1–Apr. 26) and from 9:15 to 17:30 (Apr. 27–Sept. 1).

While work is ongoing, roofed scaffolding has been erected over the entire main keep, to

protect it from the elements and ensure that repairs are able to progress smoothly and safely throughout. As World

Heritage status extends to the grounds surrounding the castle as well as the buildings themselves, the scaffolding could not be attached directly to the roof or walls, and the builders were not permitted to drive stakes into the ground. Steps also had to be taken to prevent the weight of the roofed scaffolding from distorting the ground in any way. The solution came in the form of a steel frame truss structure designed to be as lightweight as possible.
